Inspection No. 2986-1575

# Visual Property Inspection

7 Glenview Pl., Huntington, New York 11743

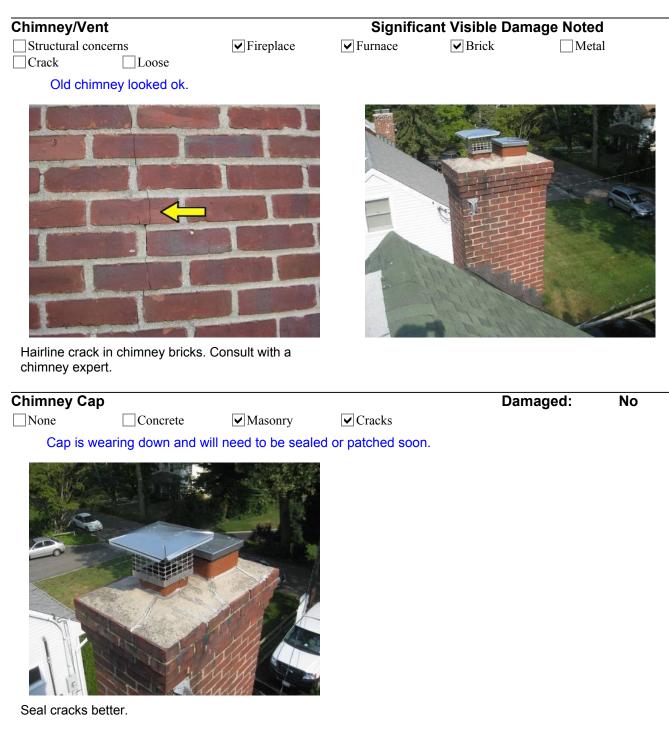
Outer covering starting to crack.

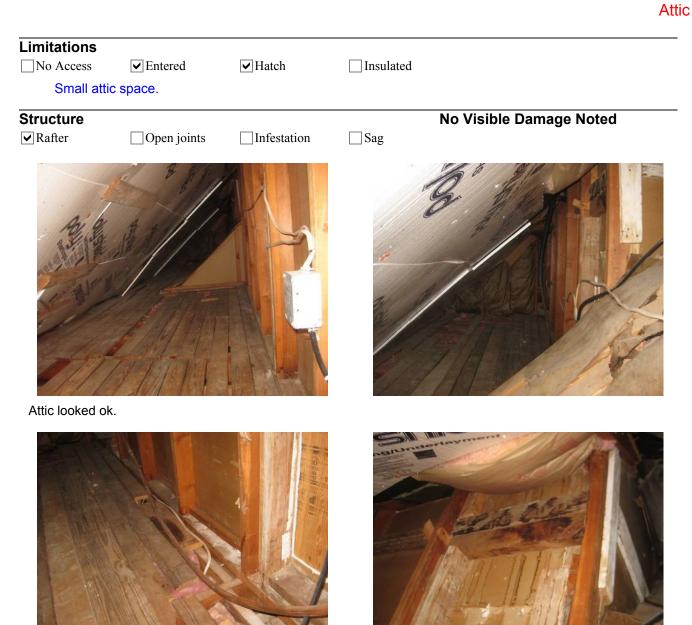
Top mounted damper for fireplace.

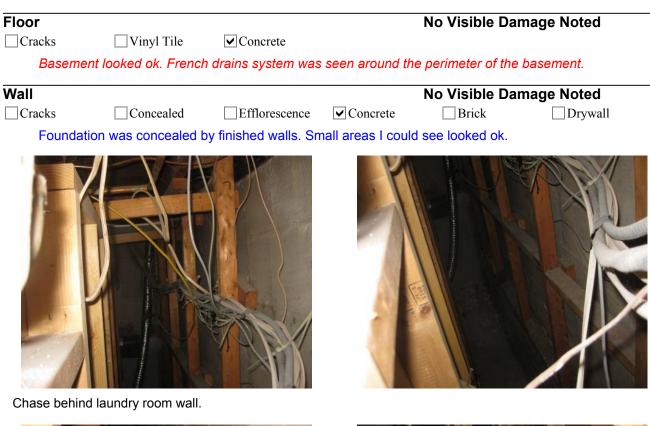
wall behind washing machine wall.

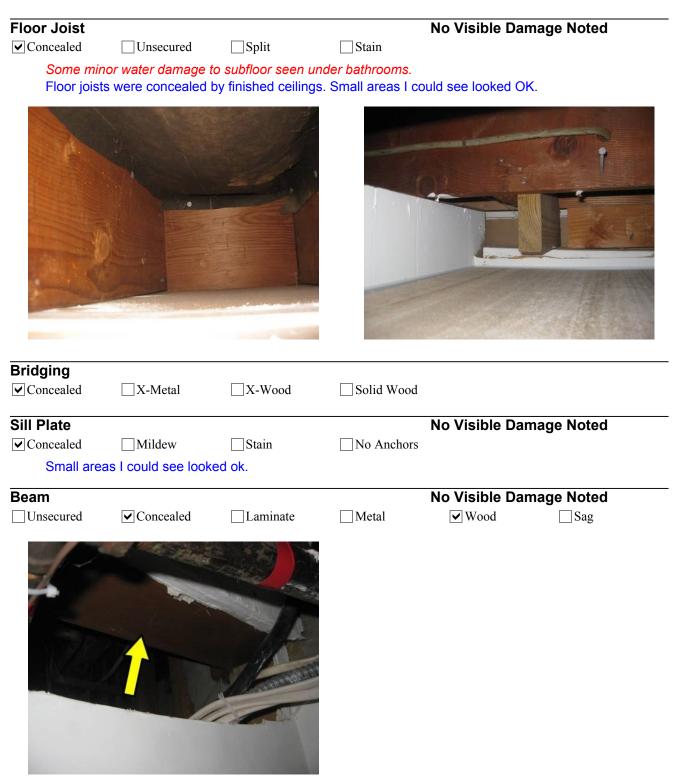
Wood beam.

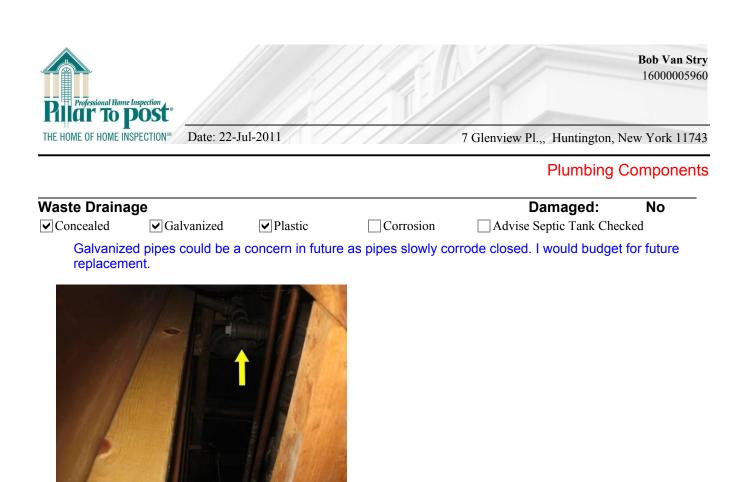
Galvanized waste pipe.
